**DEPARTMENT OF TRANSPORTATION**

Contract #: 04-0120F4Cty: SF/ALA Rte: 80 PM: 13.2/13.9File #: 69.28**WELDING INSPECTION REPORT****Resident Engineer:**Pursell, Gary**Address:** 333 Burma Road**City:** Oakland, CA 94607**Report No:** WIR-002701**Date Inspected:** 12-May-2008**Project Name:** SAS Superstructure**OSM Arrival Time:** 700**Prime Contractor:** American Bridge/Fluor Enterprises, a JV**OSM Departure Time:** 1500**Contractor:** Zhenhua Port Machinery Company, Ltd (ZPMC), Changxing Island **Location:** Shanghai, China**CWI Name:** Luan zhoa Gang (07120761)**CWI Present:** Yes No**Inspected CWI report:** Yes No N/A**Rod Oven in Use:** Yes No N/A**Electrode to specification:** Yes No N/A**Weld Procedures Followed:** Yes No N/A**Qualified Welders:** Yes No N/A**Verified Joint Fit-up:** Yes No N/A**Approved Drawings:** Yes No N/A**Approved WPS:** Yes No N/A**Delayed / Cancelled:** Yes No N/A**Bridge No:** 34-0006**Component:** Side Plates, Bottom Plates and Deck Sections**Summary of Items Observed:**

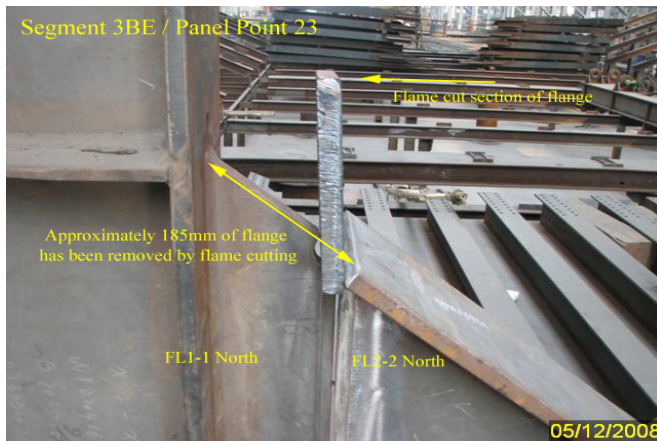
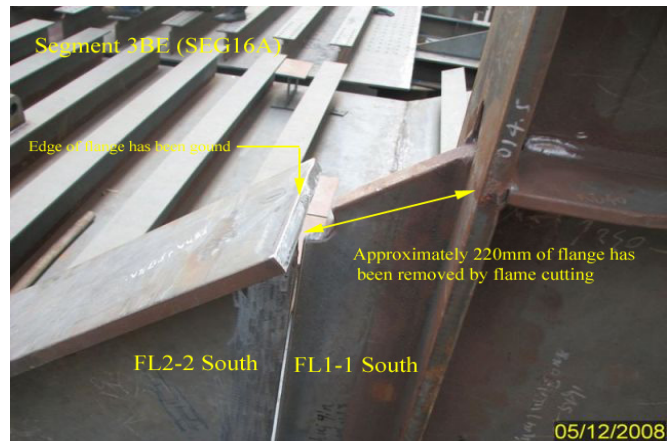
Segment 3BE (SEG16): Caltrans QA observed ZPMC personnel erecting the floor beam cross bracing section identified as FB-002-02 Panel Point(PP) 23. The section has been tack welded to segment 3BE-D6. However, it should be noted that during the installation of the section ZPMC personnel flame cut the North and South ends of the flange on FL2-2. The flange ends had been removed so segment would fit between FL1-1 North and FL1-1

South. The sections of the flange lengths that have been removed measure at approximately 180mm on the North end and 225mm on the South end. See attached photos.
